## **GOODS RECEIVED BUT ALLEGEDLY DEFECTIVE?**

# INFORMATION SHEET ON RUBBER COVERINGS

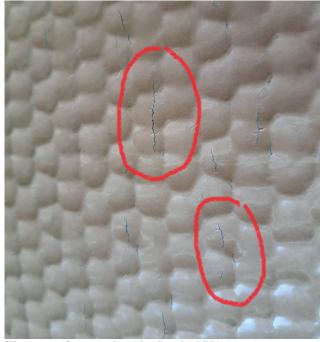
During our production process we use so-called silicone paper. This is a release paper with a silicone layer, which ensures that the rubber does not stick to the metal mould. This paper is reused approx. 2-4 times - in the spirit of sustainability, as it has to be disposed of afterwards. Due to the high pressure and the heat, the paper gets small tears, some of which are found in the surface of the rubber coating. It looks as if the rubber is cracked - fortunately this is not the case!

Silicone paper after approx. 2 uses (small cracks visible)

✓ It is only an imprint and does not affect the functionality.

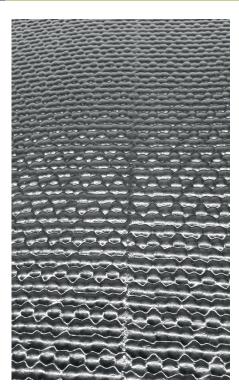
Impression of a weld seam in the embossing plate

Impressions of the weld seam

Weld seam in sheet metal

Similar to the case on the underside, some of our rubber coverings, which provide the proven hammered-blow profile on the top side, also have to be welded together. Here, too, weld seams are created that are pressed onto the top side and make it look as if they were vulcanised together afterwards. This is also deceptive!
